MANUAL TEDGUM

REPLACING THE POWER BRAKE SEAL **TEDGUM® 00748698** (Manual #33)

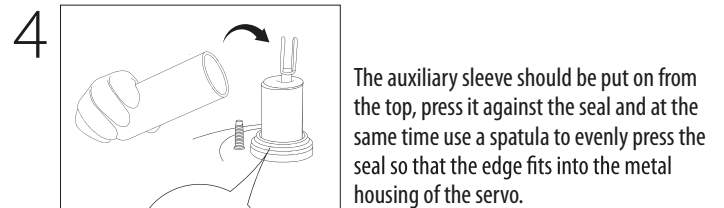
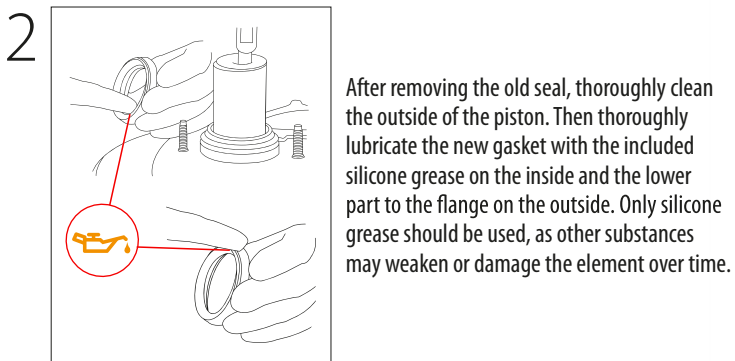
We present below the subsequent stages of replacing the gasket:

Loss of tightness on the working piston is a common brake servo failure. The symptom of the fault is a characteristic hissing sound when pressing the brake. This fault can be easily repaired by replacing the gasket with a new one. The replacement process is not complicated, but care must be taken not to damage the piston surface. Even a minor scratch on the piston may result in the need to replace the entire element.

Once the seal is installed, the servo can be reinstalled in the car.
