MANUAL TEDGUM

Installation of the bushing TED96804

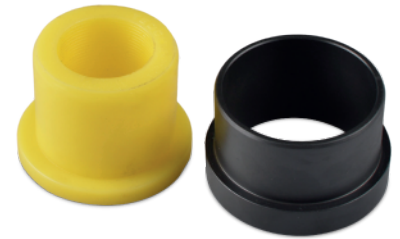
One of the unusual suspension solutions is the control arm link in BMW 5 Series (E39, E60, E61), 6 (E63, E64), 7 (E38, E65, E66, E67), X5 (E53), Z8 (E52). The link consists of 2 metal-rubber bushings, one of which has an additional element attached in the form of a metal rod. In the case of replacing standard bushings with polyurethane ones, this original rod should be used. The polyurethane set consists of 2 elements: an external metal sleeve and a polyurethane element.

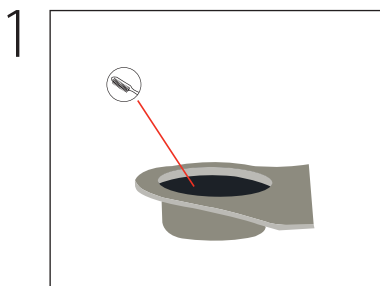
The old bushing should be removed and then the socket should be thoroughly cleaned, remembering to keep the rod that is placed in the original bushing, as it will be reused

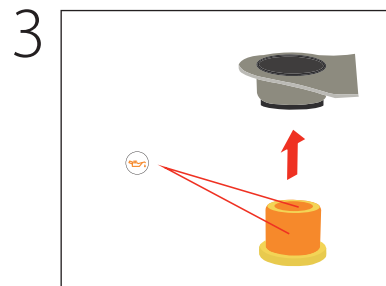
The polyurethane bushing needs to be thoroughly lubricated on the outside, and then the metal sleeve needs to be pressed in until it is level.

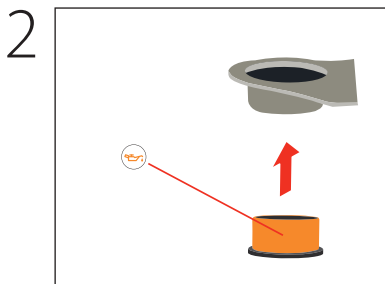
The external metal sleeve is pressed into the socket after thoroughly lubricating the external surface.

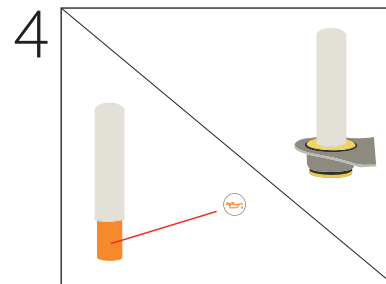
Before installation, the indicated places should be thoroughly lubricated.

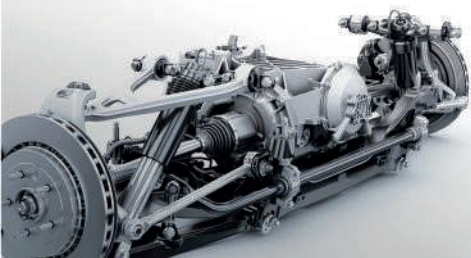
Finally, the original rod dismantled from the old bushing should be installed.
