# MANUAL TEDGUM

## Replacing the SAAB 9-3 engine mount insert (Manual #6)

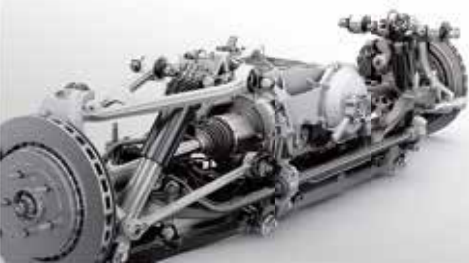
11 A properly repaired element should look like above.
